## Infrared Camera Characterization of Bi-Propellant Reaction Control Engines During Auxiliary Propulsion Systems Tests at NASA's White Sands Test Facility In Las Cruces, New Mexico

### ABSTRACT

This paper describes the application of a FLIR Systems A40M infrared (IR) digital camera for thermal monitoring of a Liquid Oxygen (LOX) and Ethanol bi-propellant Reaction Control Engine (RCE) during Auxiliary Propulsion System (APS) testing at the National Aeronautics & Space Administration's (NASA) White Sands Test Facility (WSTF) near Las Cruces, New Mexico. Typically, NASA has relied mostly on the use of ThermoCouples (TC) for this type of thermal monitoring due to the variability of constraints required to accurately map rapidly changing temperatures from ambient to glowing hot chamber material. Obtaining accurate real-time temperatures in the IR spectrum is made even more elusive by the changing emissivity of the chamber material as it begins to glow. The parameters evaluated prior to APS testing included: (1) remote operation of the A40M camera using fiber optic Firewire signal sender and receiver units; (2) operation of the camera inside a Pelco explosion proof enclosure with a ge

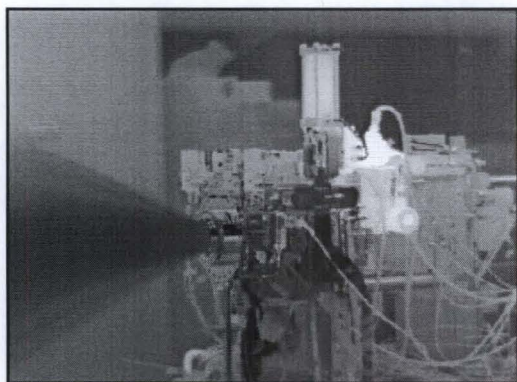
**Figure 3.**  
Fuel cold-flow Test 30, 1.25 sec. test.

appeared during test that the two various types of instrumentation matched closely with each other. The infrared sensor is limited to  $-45^{\circ}\text{F}$  as indicated by the dark shades of the cryogen supply lines to the injector.

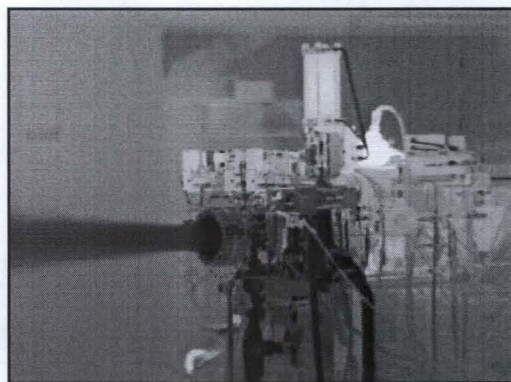
**Figure 4.**  
LOX cold-flow Test 34, 15 sec. test.

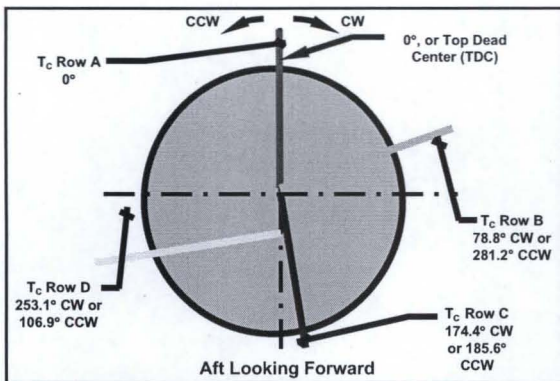
**Figure 5.** ATP thermocouple location section.

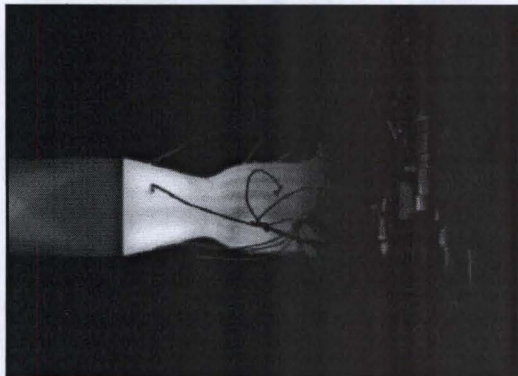
**Figure 9. Hot-fire Test 124.**

Test 124 was used to compare data recorded by the FLIR Systems A40M infrared camera using the ThermoCAM Researcher Pro 2.8 software to that of the vendor's Data Control Acquisition System (DCAS) using Winplot. Test 124 was a 60 second steady-state hot-fire test. The thermal data shown in Figures 5-8 represent the time just prior to the main valves being powered "off". The Winplot traces, Figure 8, from the thruster vendor thermocouple data represent the time duration for the entire test, but the temperatures are mostly constant within a horizontal band by thermocouple location. The maximum temperature from the thruster vendor's data from Thermocouple 7D indicates a temperature of  $2450^{\circ}\text{Rankine}$  whereas the maximum temperature from the A40M infrared camera LI01 indicates  $2462^{\circ}\text{Rankine}$  or  $2002^{\circ}\text{Fahrenheit}$ . The temperature slope of LI02 from the A40M infrared camera appears consistent with the temperature slope recorded by the thruster vendor thermocouples.

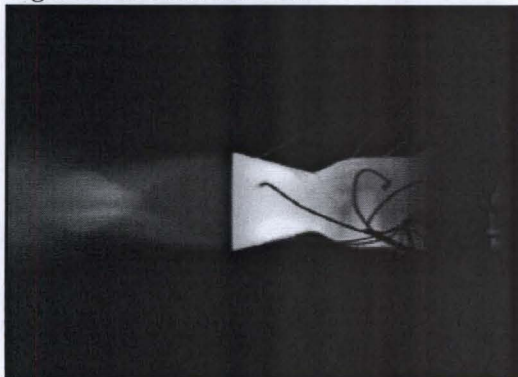
**Figure 11. Hot-fire Test 131 pulse @ max press.**

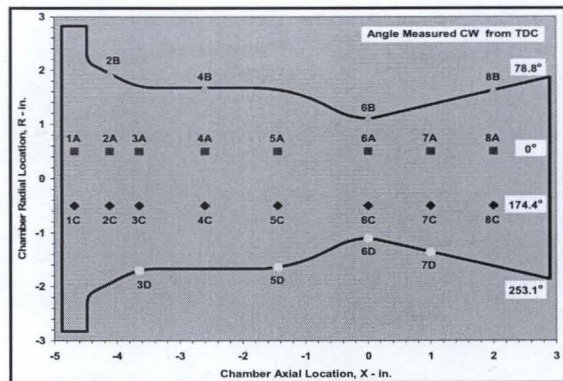
**Figure 6.** ATP thermocouple location diagram.

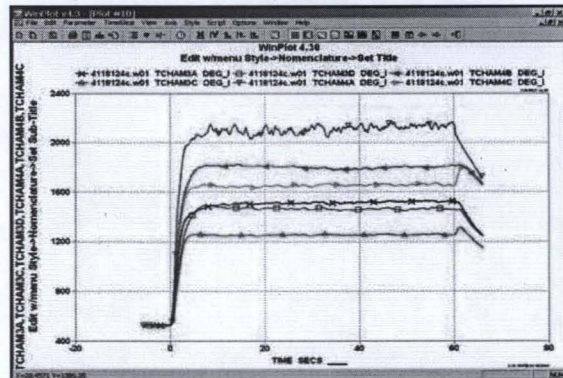
**Figure 8.** WinPlot traces.

Figures 7 & 8 indicate parallel trending for the heat affected zones where the main chamber thermocouples are located to the FLIR A40M camera data displayed within the ThermoCAM Researcher Pro 2.8 screen. Axial locations 4 to 5 are represented. Again, the thruster vendor data shown with the WinPlot traces is shown in degrees Rankine (Fahrenheit  $\approx 460$ ) and the ThermoCAM Researcher Pro 2.8 traces are shown in degrees Fahrenheit.

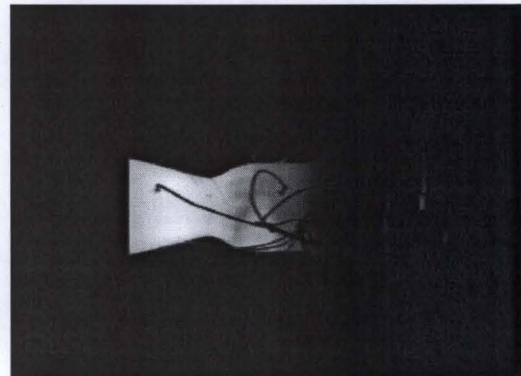
**Figure 10. Hot-fire Test 125 soak-out.**

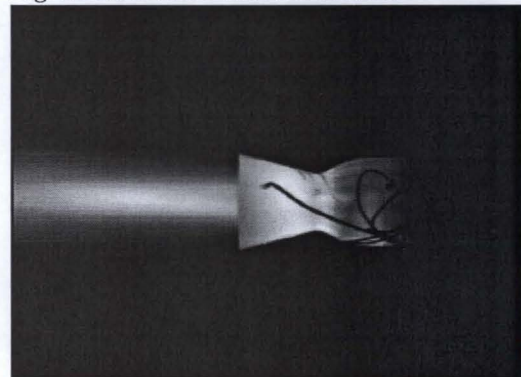
**Figure 12.** Hot-Fire Test 131 post pulse abating.

The infrared pallet shown in Figure 12 is optimized for visual clarity specific to the heat affected zones and features discussed within the text of this document. Generally, Rainbow10, Gray10, and Iron10 are best suited for visually defining heat affected zones without utilizing the excessive gradation of tone commonly seen in images such as with Figures 9-12. The ability of the FLIR A40M camera to capture the total seamless radiometric signature of the RCE main chamber during hot-fire testing is perhaps best exemplified within Figures 9-12. While associated mainly with heat radiation, they do have some properties which are the same as those of visible light.<sup>1</sup>

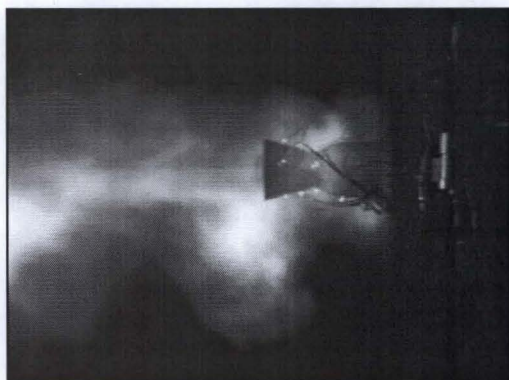
**Figure 13.** This IR imagery indicates the ignition of pooled propellant (hot gas) as the result of a previous non-ignition. The ignition occurred after the propellant was expelled from the chamber and ignited by the subsequent pulse.

**Figure 13.** Hot gas from a previous non-ignition.

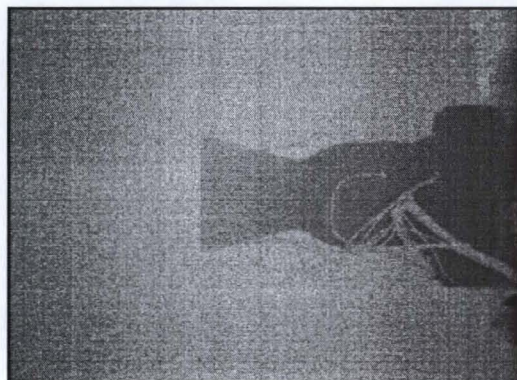
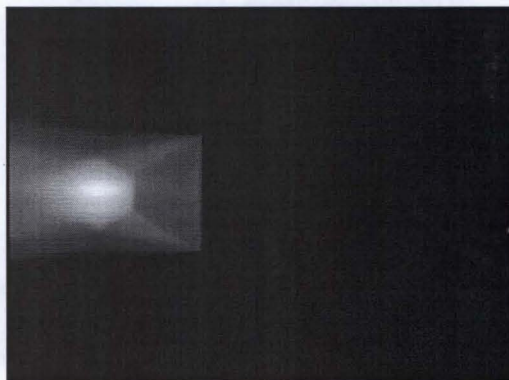
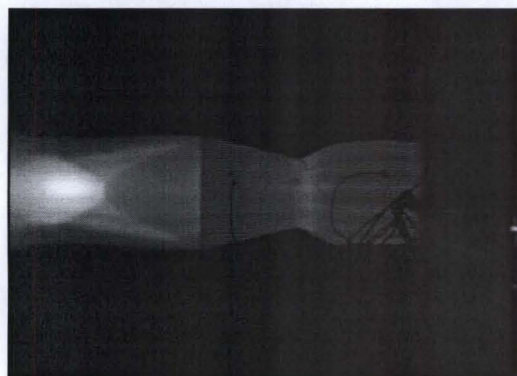
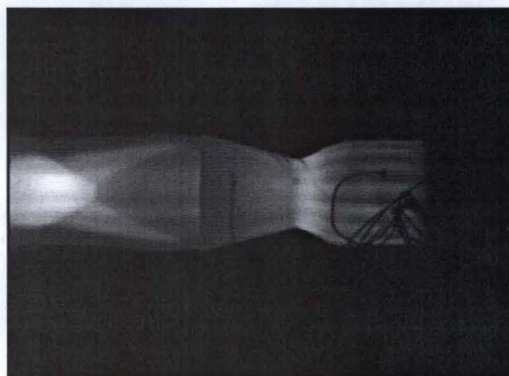
**Figures 14-17.** In the following figures, the first 4 frames of the 5 second pre-burn are shown. The images were recorded at 7.5 frames per second. In Figure 15 the rocket plume is imaged within the calibrated scale of the camera +572° Fahrenheit. The main chamber heating is not visible until the second frame in Figure 16. In Figure 17, the radial Fuel Film Cooling (FFC) pattern is easily seen upstream of the throat section.

**Figure 14.** Test 151 pre-pulse.

**Figure 15.** Test 151 Pulse one frame one.

**Figure 16.** Test 151 pulse one frame two.

**Figure 17.** Test 151 pulse one frame three.

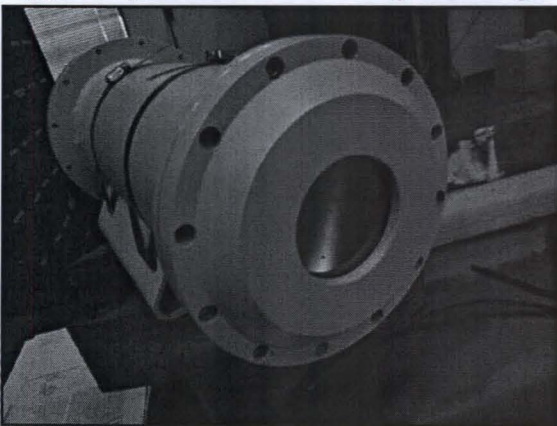
Figure 19. Pelco enclosure with Germanium lens installed.

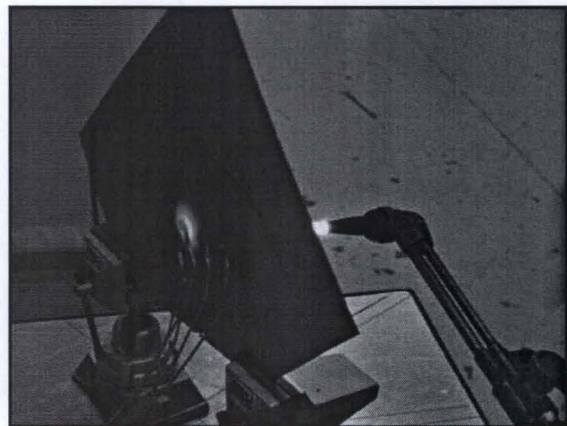
Figure 20. Heat being applied to instrumented panel.

The objective for the FLIR Systems A40M IR Camera HIL Tests was primarily to validate the accuracy of the camera to the standard reference Type K TCs planned for use at WSTF during APS testing. This was the first opportunity to test the A40M IR camera within the Pelco explosion-proof enclosure illustrated in Figure 19. A Germanium lens was used to ensure that the camera could detect heat outside of the enclosure while remaining protected inside the enclosure. Heat sources utilized included: electric heat gun, propane torch, map torch, and oxygen acetylene torch as shown being used in Figure 20.

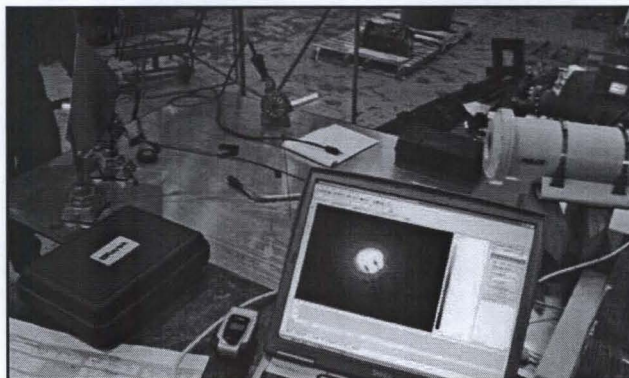
**Figure 21.** Typical setup from Sequence Tests 30-35 using the Pelco enclosure.

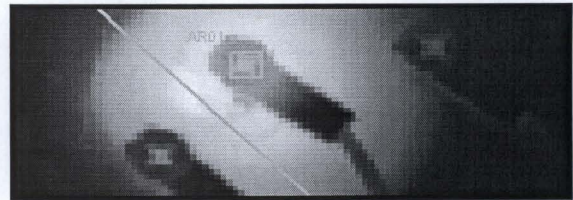
Figure 23. Enlarged Thermocouple analysis area.

The temperature goal for this test was 1750°F. The general thermocouple arrangement is represented by the ThermoCAM Researcher Pro 2.8 screen as shown in Figure 22. Figure 24 contains the analog thermocouple data of 1742°F from Thermocouple 3 during the same time frame as Figure 23 from the IR screen. The string data exported from the ThermoCAM program is represented in the tabular data shown in Figure 25 which is representative of the pixel arrangement contained within the white-bordered box in Figure 23.

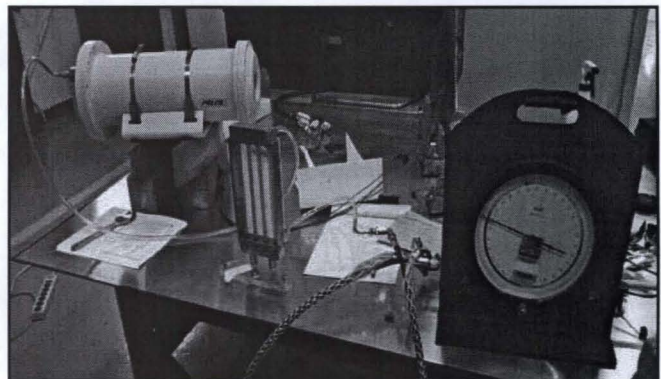
Figure 27. Pressure test with Kellum tether.

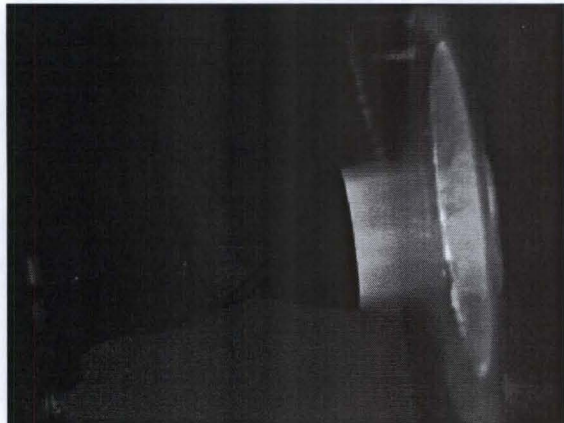
**Figure 28.** Initial pulse before chamber heating.

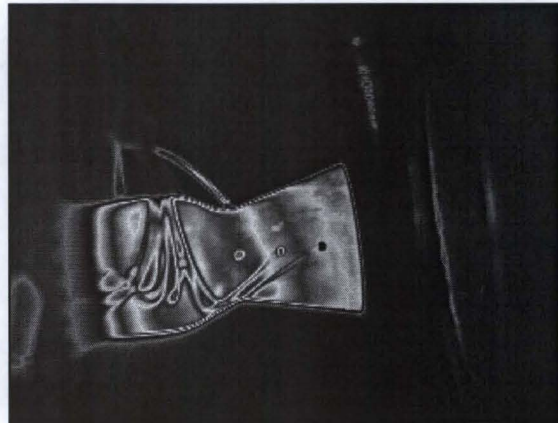
**Figure 29.** Thermal Soakout during coast period.

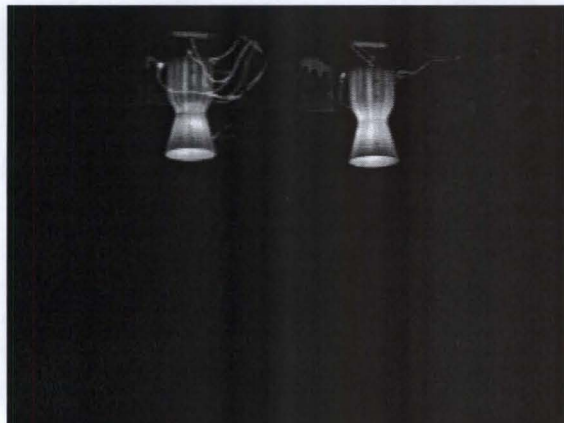
**Figure 30.** Screen-shot of sequenced engine firings.

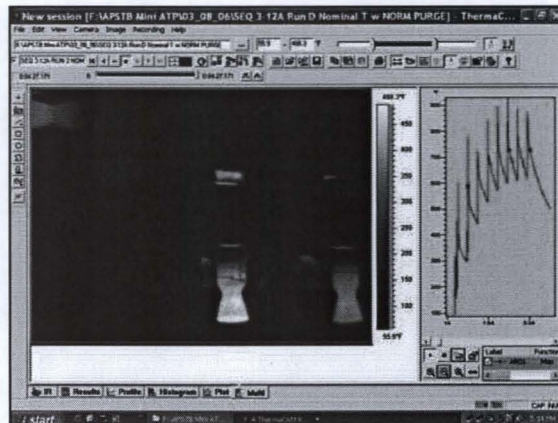
**Figure 31.** Simultaneous hot-fire at vacuum.

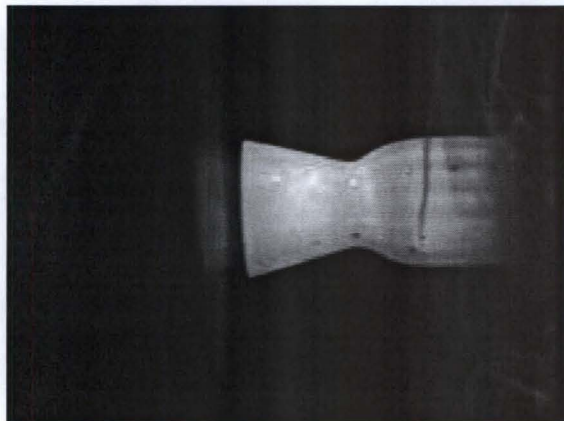
**Figure 32.** Normal hot-fire pulse.

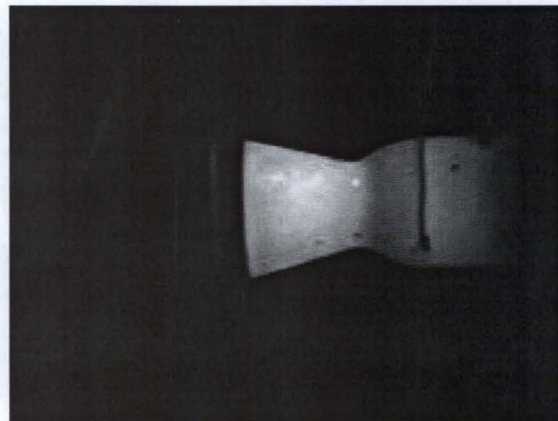
**Figure 33.** Missed ignition/cold chamber.
